STOP THE SNEAKY LEAKS

The Strategy Behind Fort Lauderdale's
Cost-Effective I&I Reduction for a
Resilient Future

Inflow and Infiltration Program

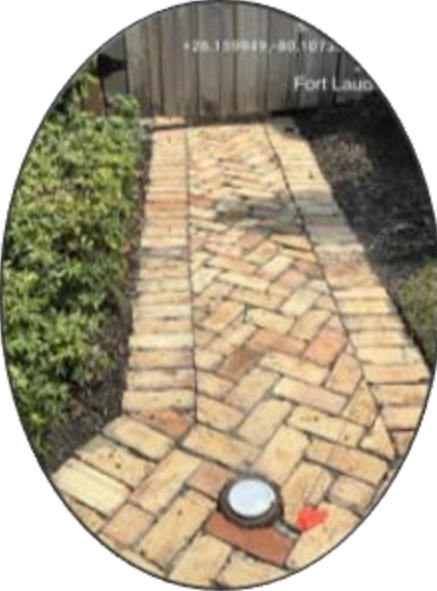
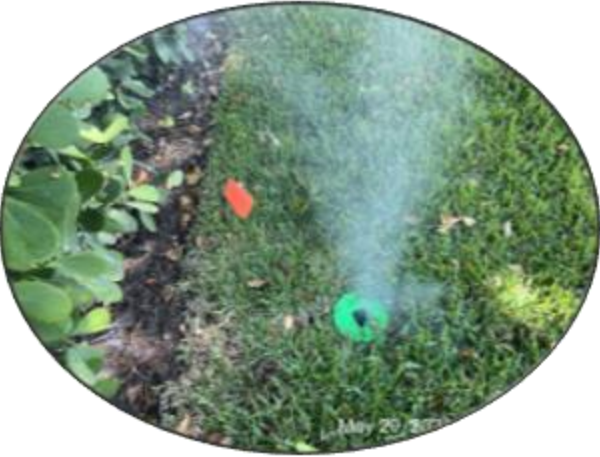
Defects Identified - Cleanouts

Cleanout Cap Replacement

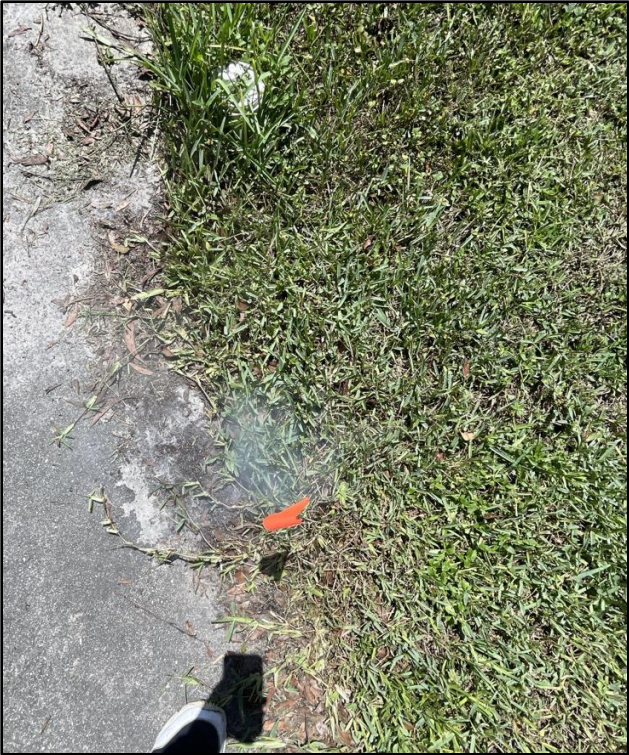
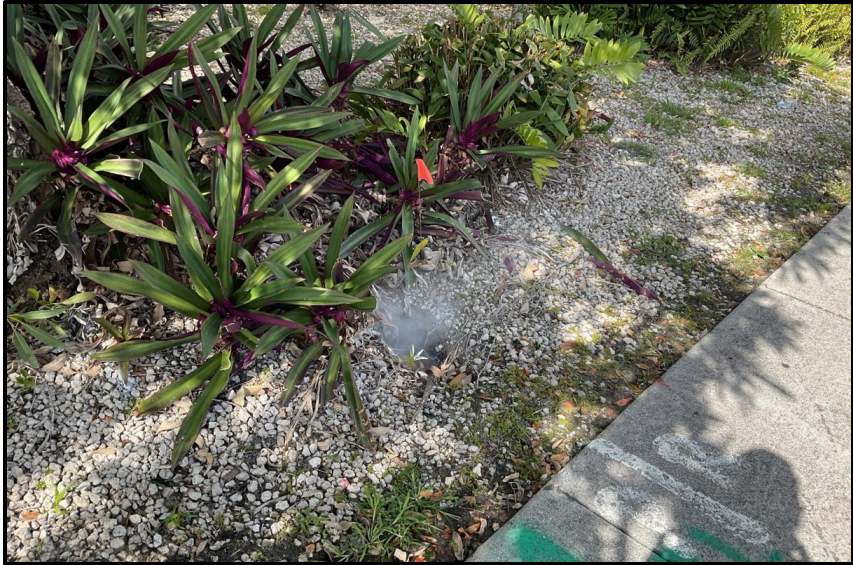
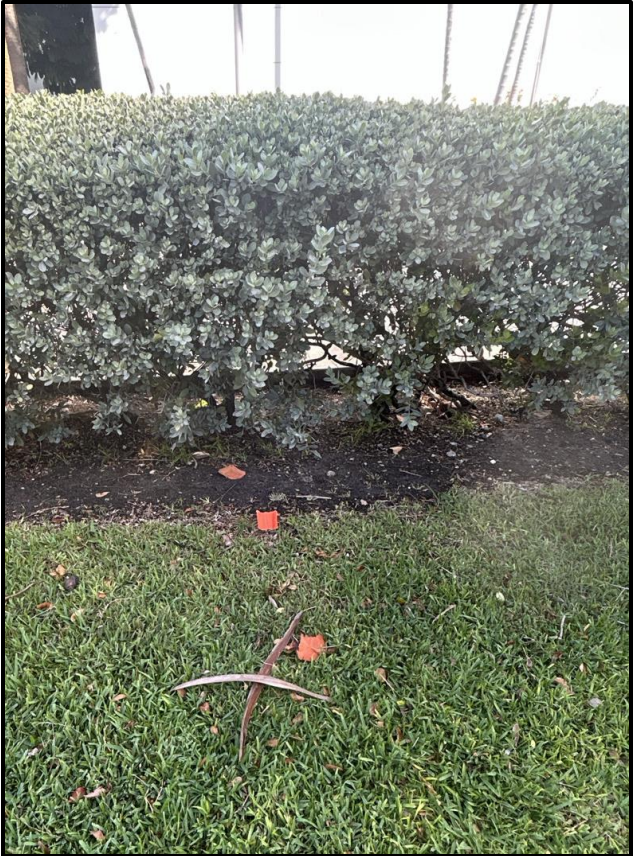
Defects Identified – Pipeline Defects

Further Investigation
of Mains or Laterals

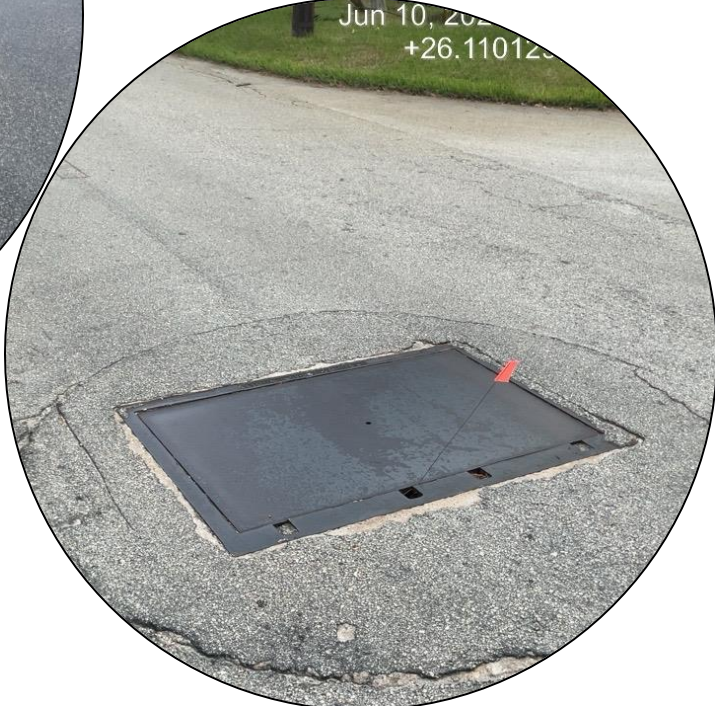
Manhole Defects

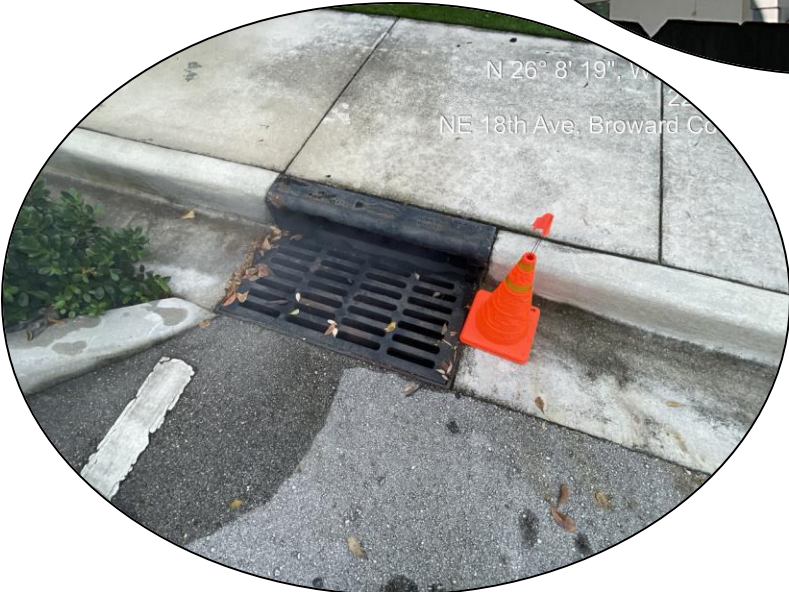
Stormwater Cross Connections

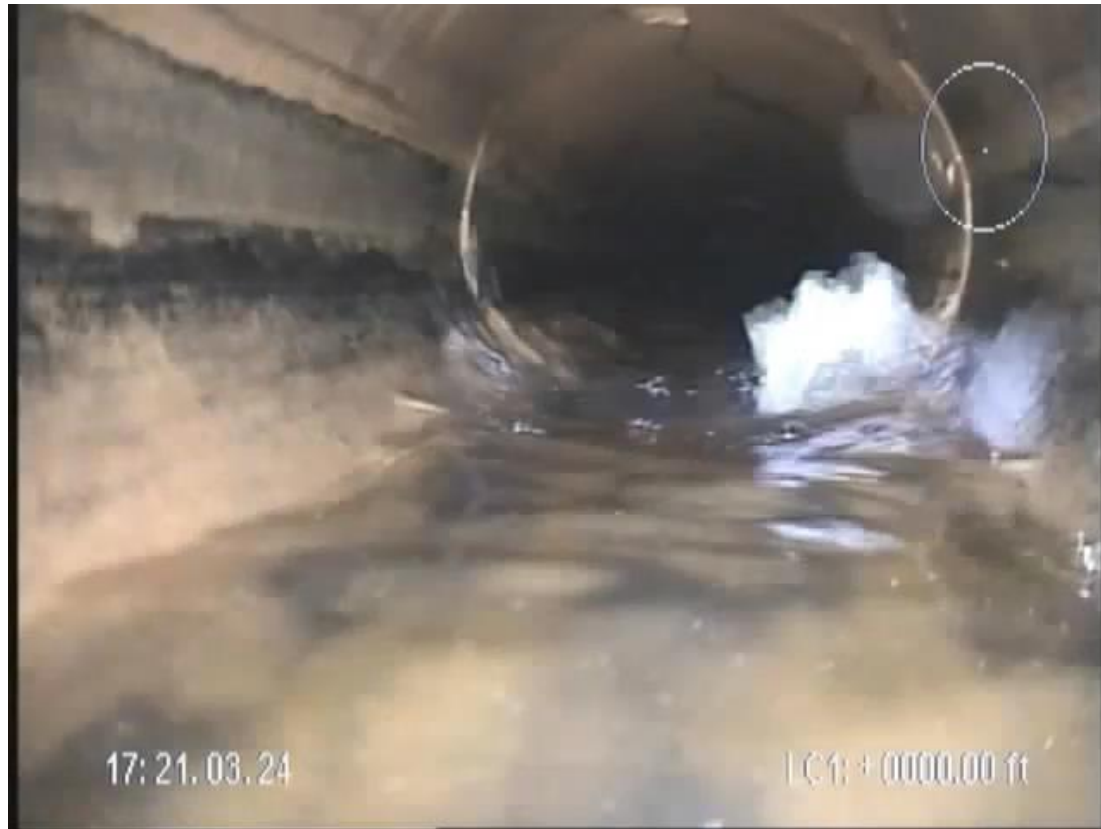
IGJ (Infiltration Gusher Joint) – separated joint

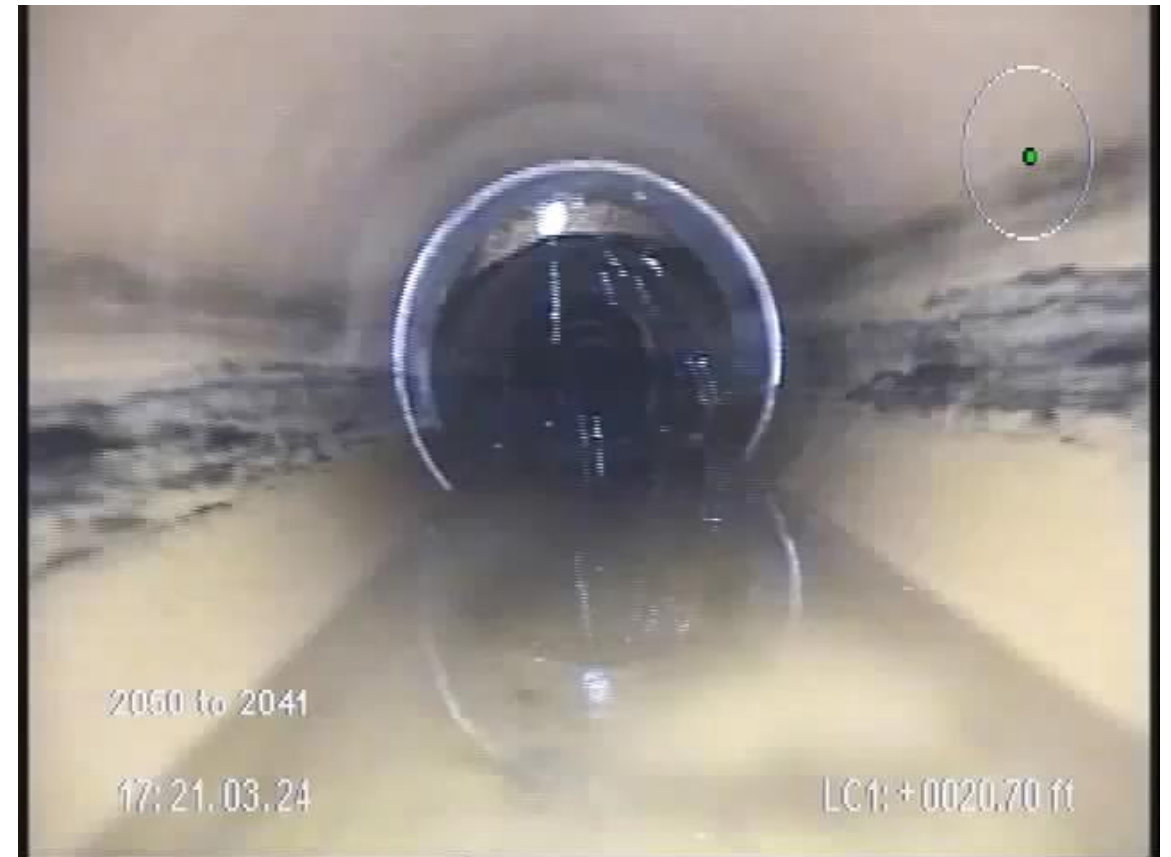
IRC (infiltration runner connection) due to a defective connection/tap

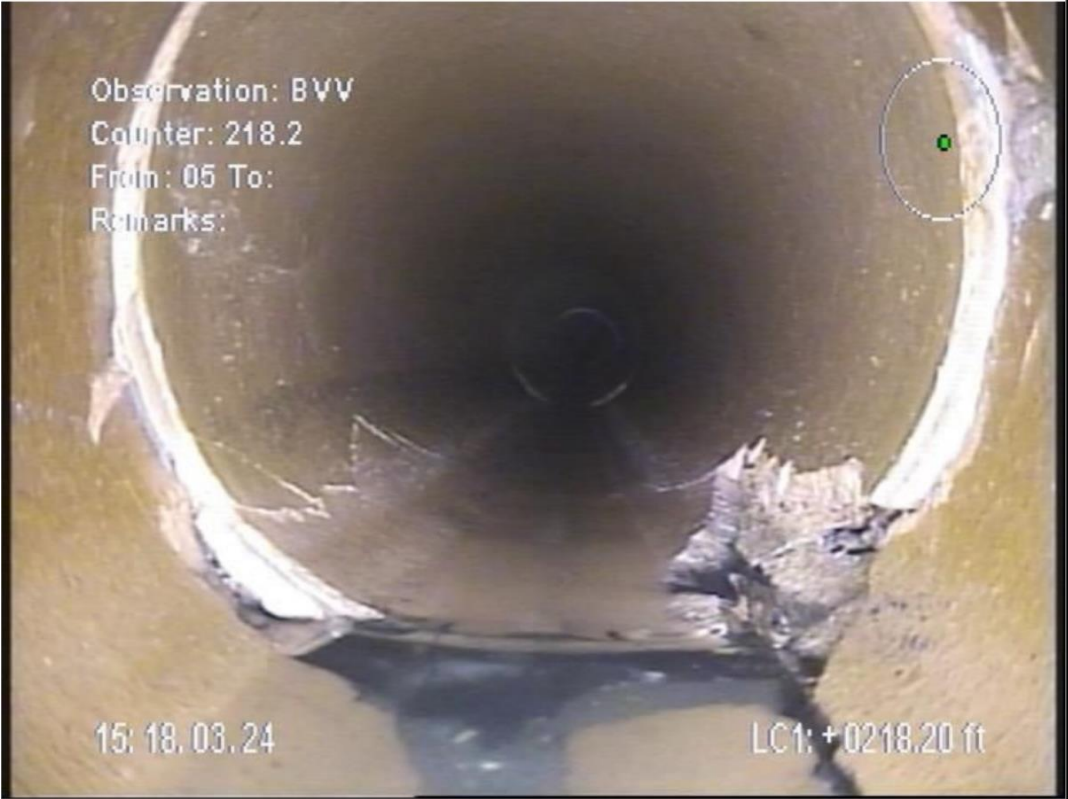
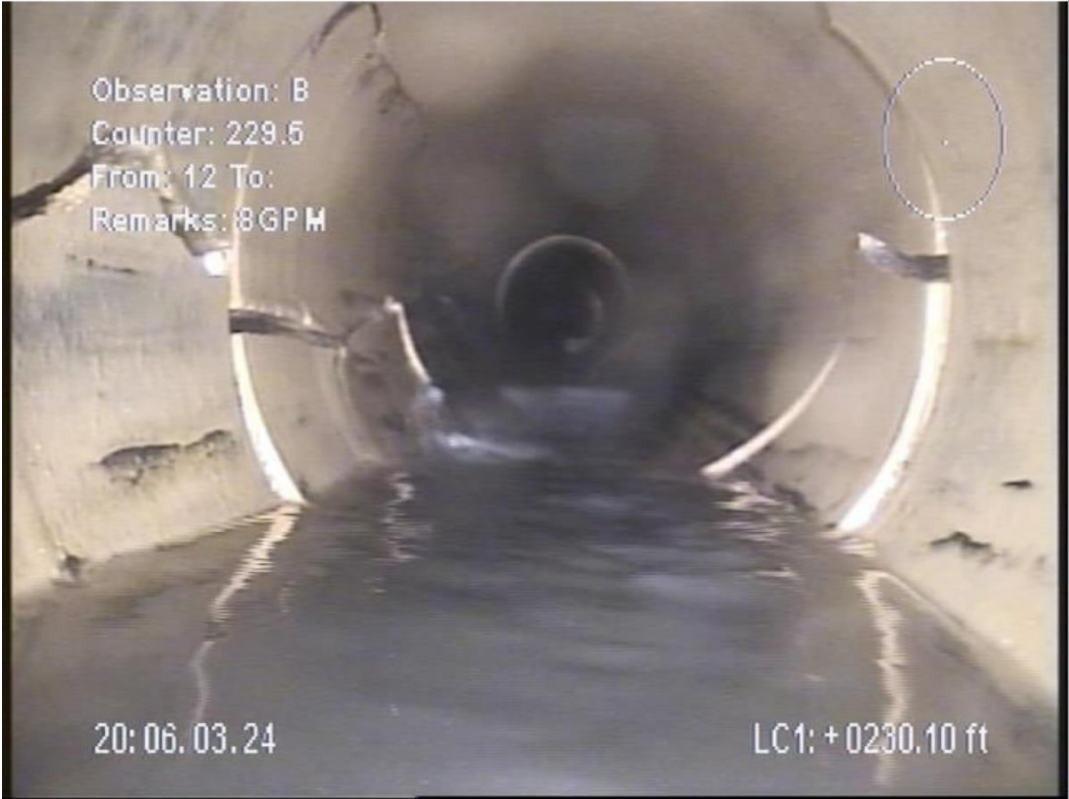
Identification of Major Pipe Defects
